Preliminary Salinity Assessment: 57 Station Road, Seven Hills, NSW

P2007944JR03V01
May 2021

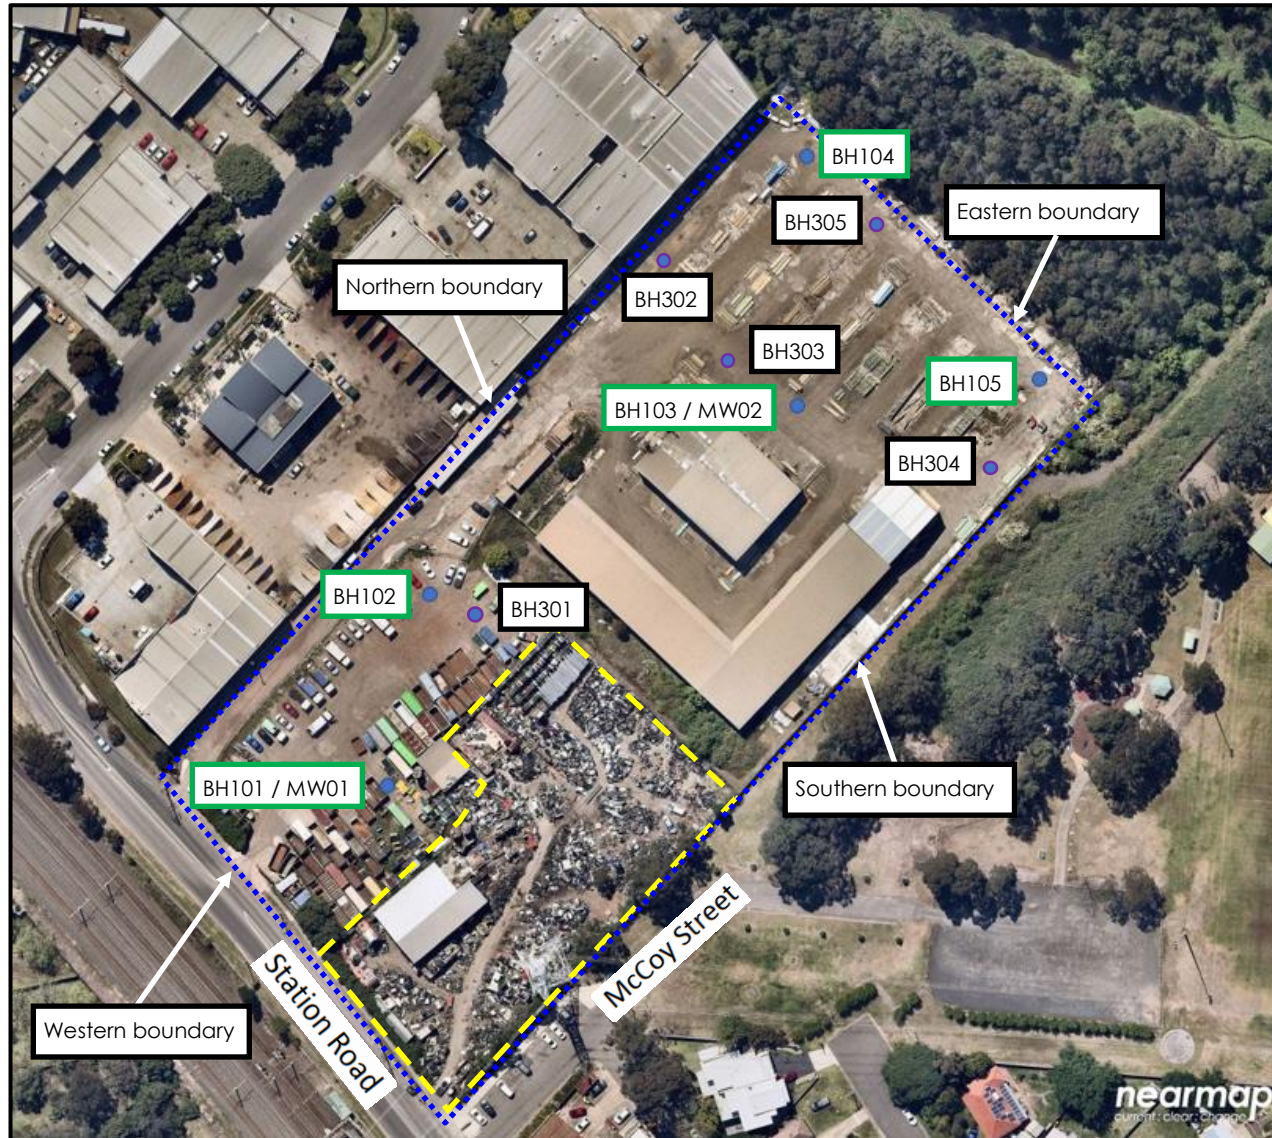
| Drawing: | FIGURE 1 |

- Indicative borehole and monitoring well locations
- ⋯ Indicative site boundary
- Area not investigated
