Project Echidna

Geotechnical Desktop Study

Reference: Appendix K

Final | 18 August 2022

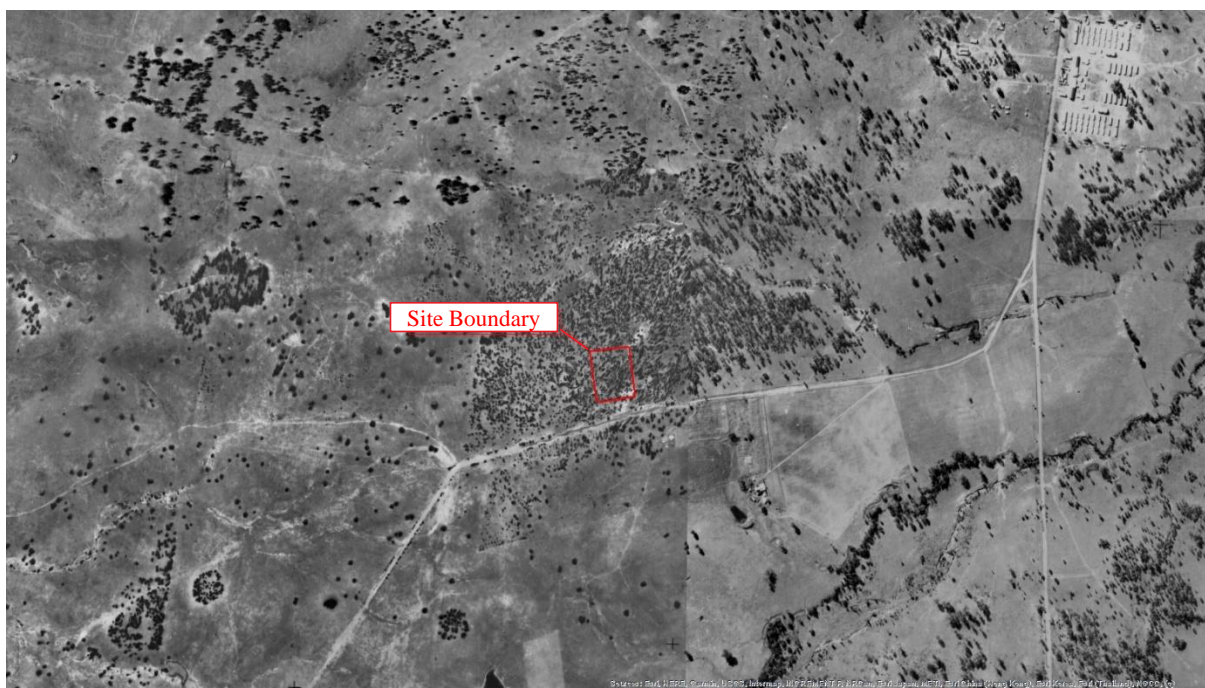
Figure 3 Aerial Imagery 1947 marked with Site boundary (Source: Lotsearch)

The earliest available aerial imagery for the site is from 1947 and showed the site was vegetated and undeveloped, surrounded by bushland and farmland as shown in Figure 3. Imagery from 1947 to 2005 show vegetation has been cleared and the site and surrounding area appears to have been used for agricultural purposes (Figure 3 to Figure 6). Imagery from 1975 (Figure 4) indicates a drainage path running north-south intersects the centre of the site and flows toward a creek to the north of site.

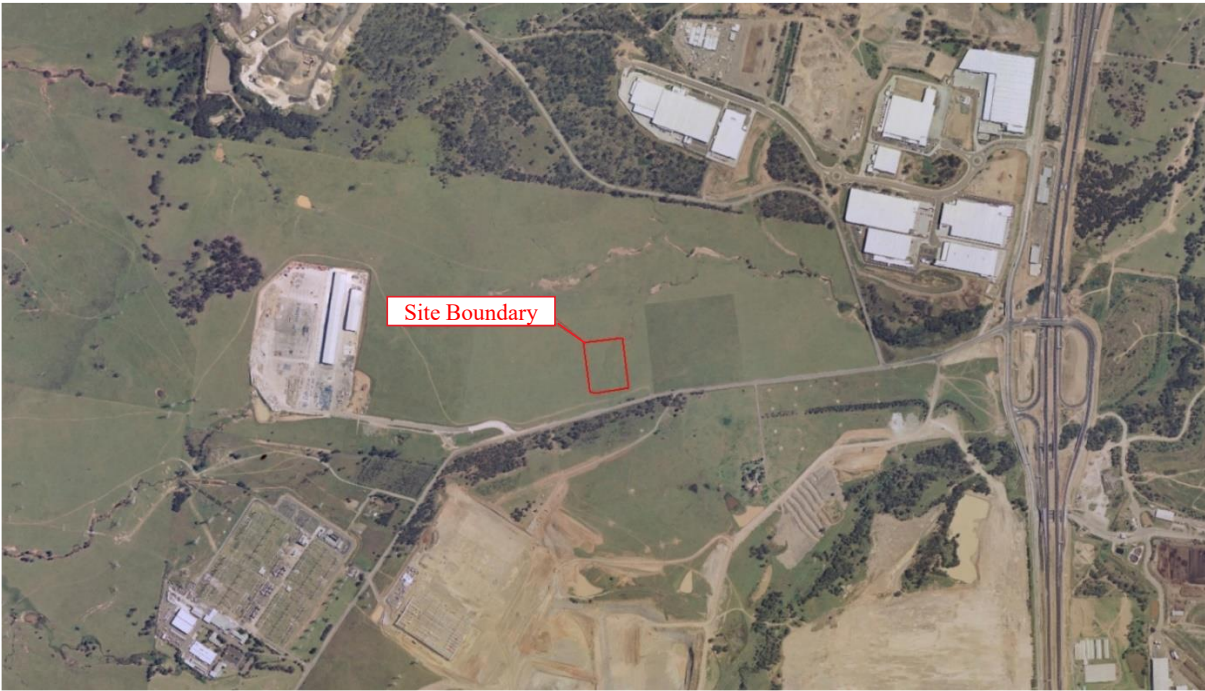
Figure 6 Aerial Imagery 2005 marked with Site boundary (Source: Lotsearch)

By 2009, Eastern Creek Drive had been constructed to the west of the site and industrial development had occurred to the south (Figure 6 and Figure 7). Further development occurred between 2009 and 2018 to the east and west of the site. Current aerial imagery dated to March 2022 shows construction works including Building 1 and earthwork activities within the immediate vicinity of the site (Figure 10).

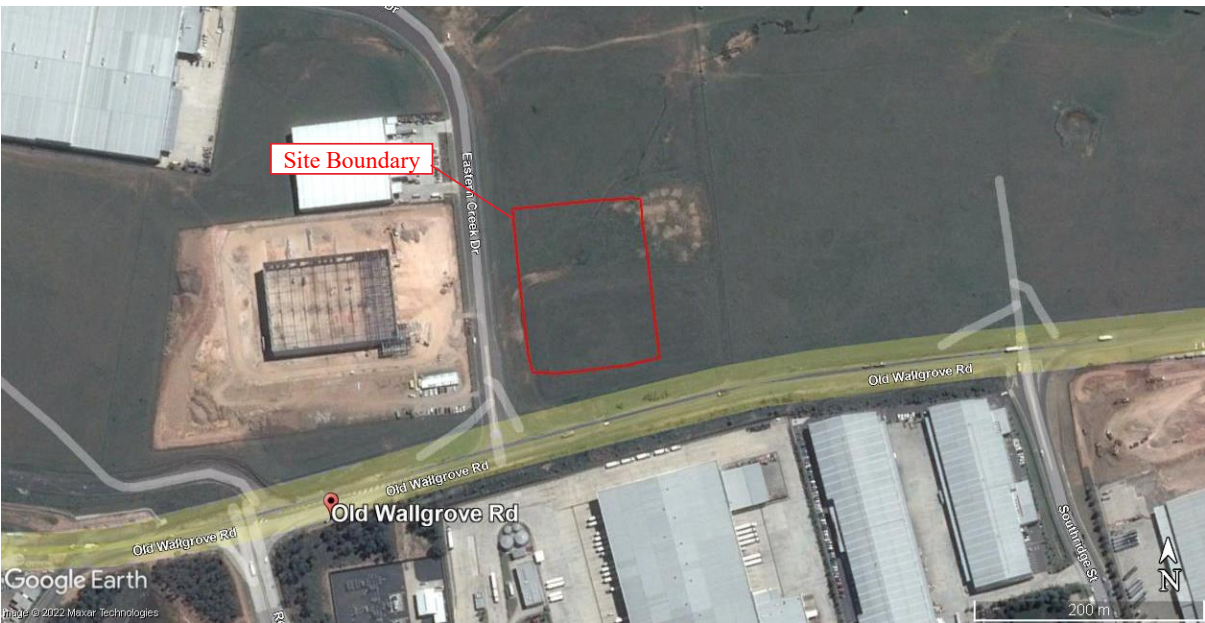
Figure 7 Aerial Imagery 2009 marked with Site boundary (Source: Google)

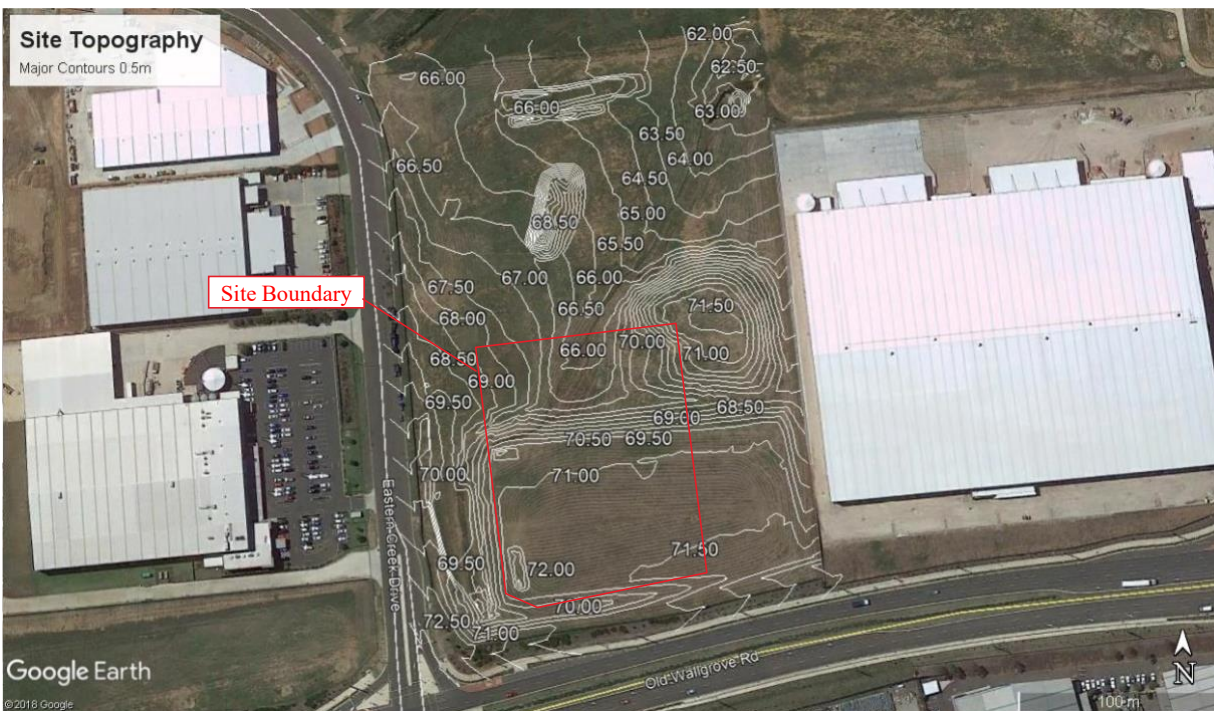
Figure 11 Pre-construction site topography (Crux Surveying Australia, 2019) superposed on satellite image [2]

Prior to the bulk earthworks, the site generally sloped from north to south with levels ranging approximately from 66m AHD at the north of the site to 70m AHD to the south (towards Old Wallgrove Road), as can be seen in Figure 11.

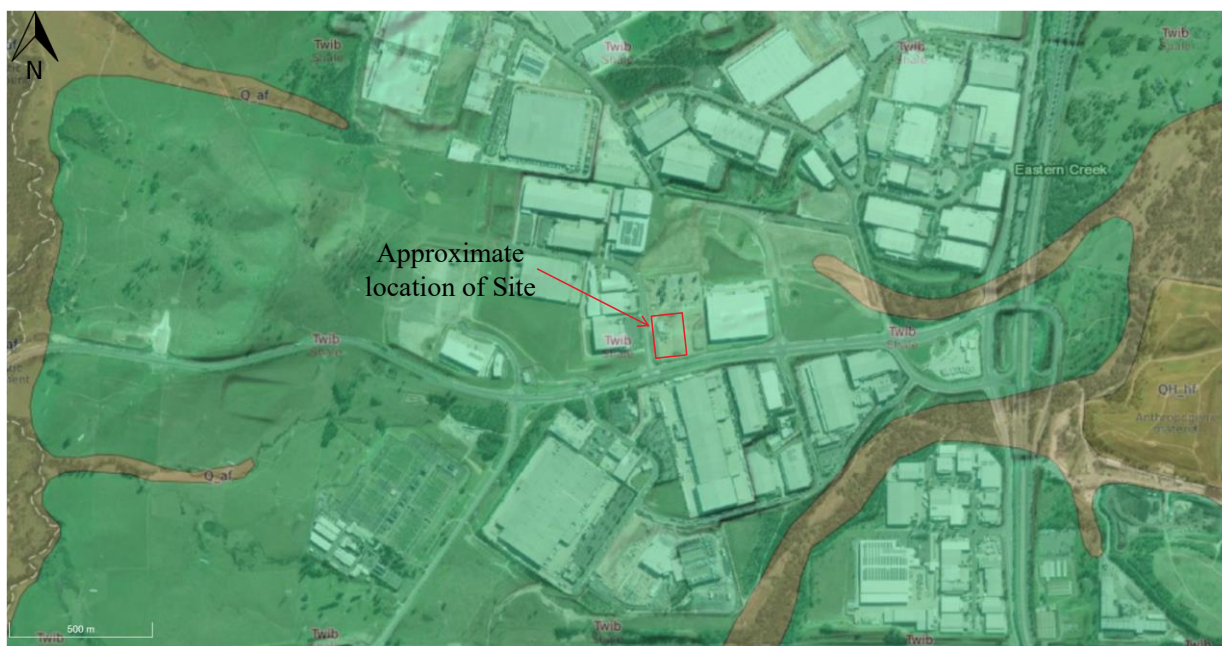
Figure 12 Regional Geology of the site [3]

Reference to the New South Wales Seamless Geology dataset indicates that the site is underlain by the Bringelly Shale of the Wianamatta Group. Bringelly shale bedrock is expected to consist of claystone/shale, laminite and sandstone. Alluvial deposits are mapped in the region but do not encroach on the site however reference to the historic imagery indicates there is a probably natural drainage line that intersects the site. It is possible that alluvial deposits associated with this drainage line may be present on the site. The geological mapping is presented in Figure 12.

No faults or dykes are mapped in the vicinity of the site.

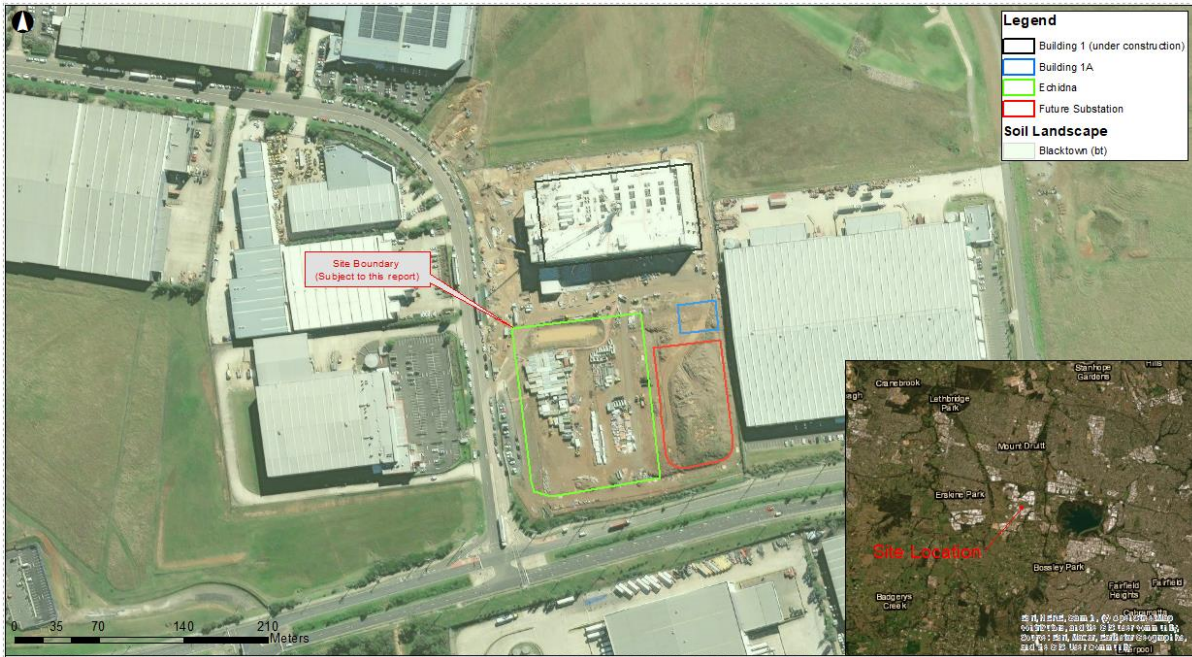
Figure 13 Soil landscape mapping of the site [4]

Soil landscapes have been interpreted with reference to the Soil Landscapes of the Central and Eastern NSW. The site is indicated to be underlain by the Blacktown Residual Soils, which are characterised as moderately reactive and plasticity with potential for seasonal waterlogging and water erosion. A more detailed description of this soil landscape is presented in Table 3.

It should be noted that the Soil Landscape Map is a regional scale map which may not be representative of conditions at a site level. The soil units suggested by the Soil Landscape may or may not match the regional geological units due to the scale and the different purpose of the map in nature.

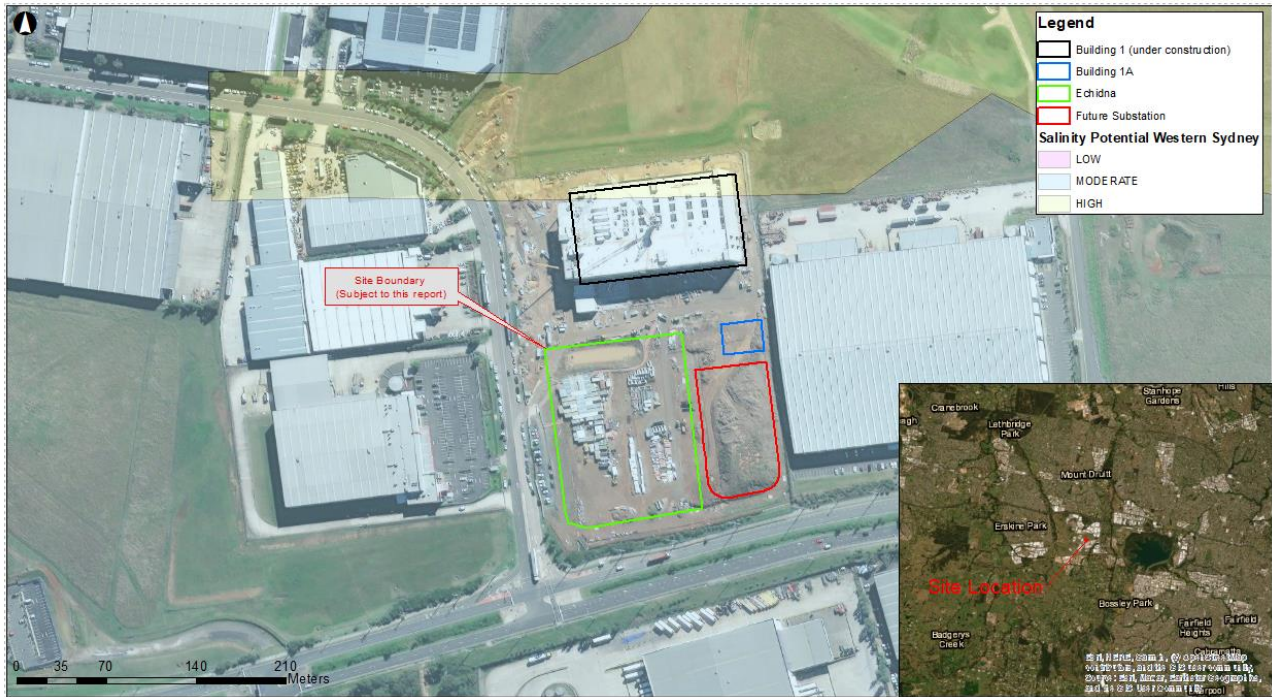
Figure 16 Soil salinity classification of Western Sydney [7]

In contrast, Department of Infrastructure, Planning and Natural Resources (DIPNR), conducted a study of the salinity potential in Western Sydney in 2002. The map produced as a result of the study depicts localised salinity categories for all the areas of Western Sydney and makes reference to associated landscapes and landform – geology (DIPNR, 2003). The map shows the site is located within moderate potential of soil salinity (Figure 14).

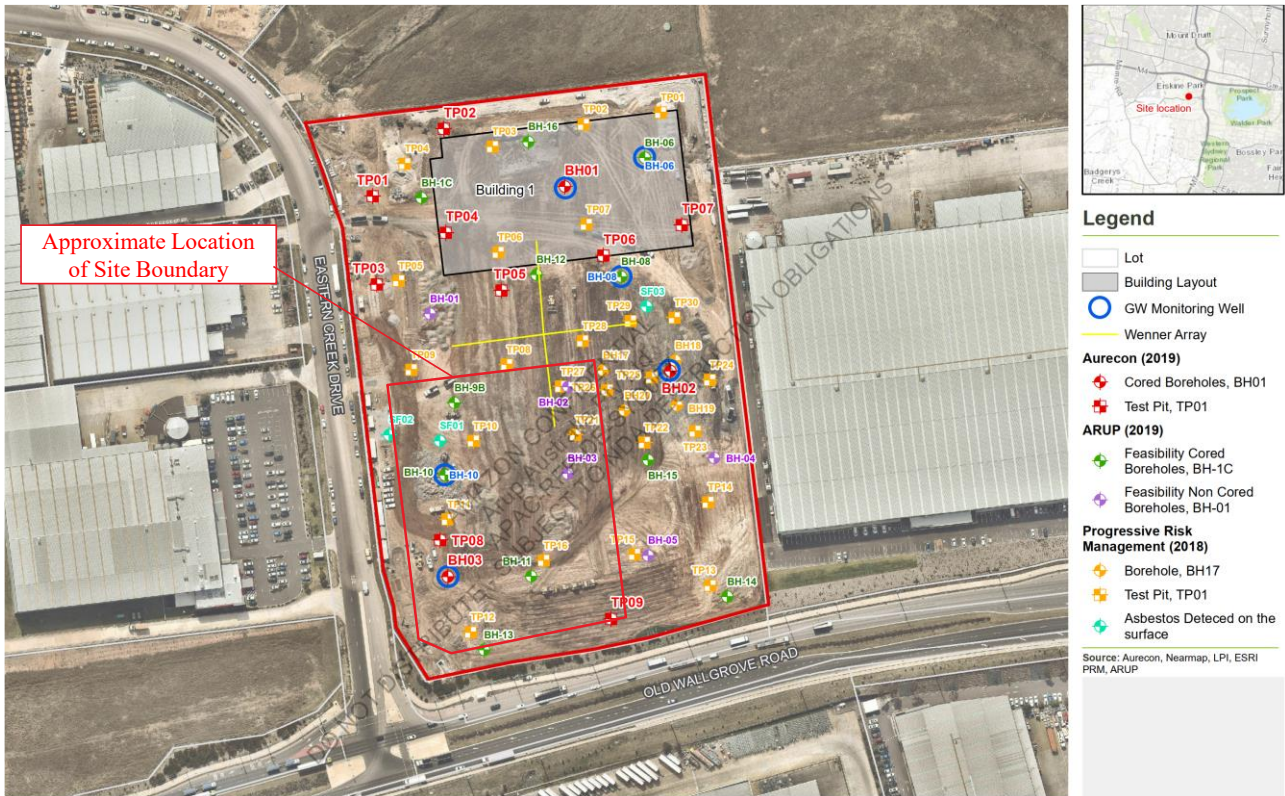
Figure 17 Location of previous site investigation [2]

The reports provided site-specific geotechnical information including geotechnical sections and detailed borehole logs. The location of the previous site investigation is shown in Figure 17. The provided information has been used to review the following:
